Appendix C - Construction Photos

An Example of a Valve Replacement - Check Valve 74

***Corrosion Investigation/Repair
- Project #X019***

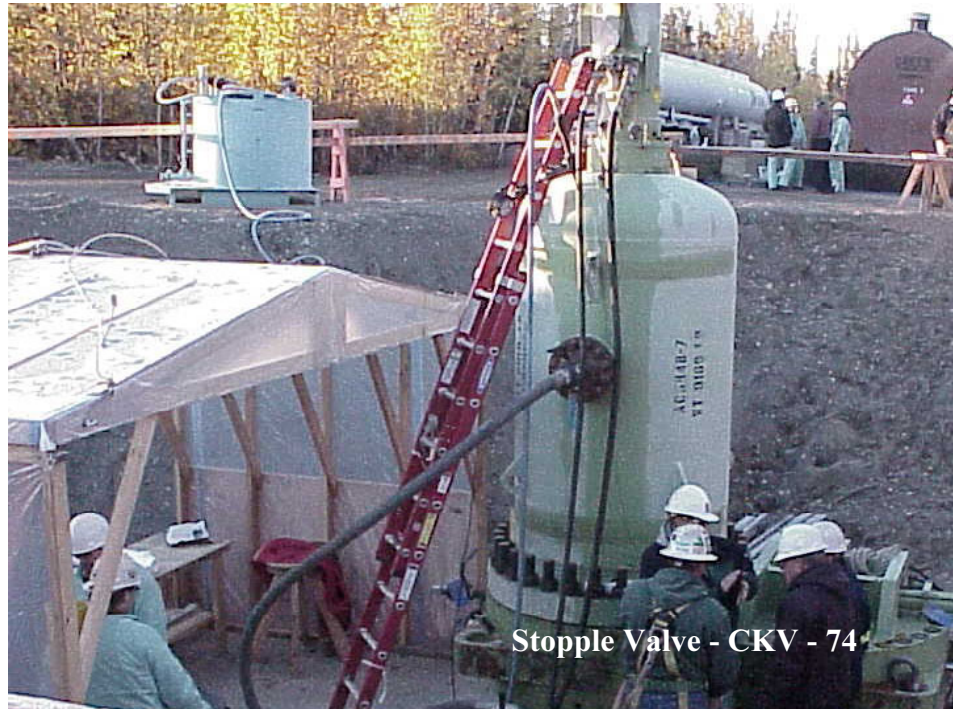
Stopple Valve - CKV - 74

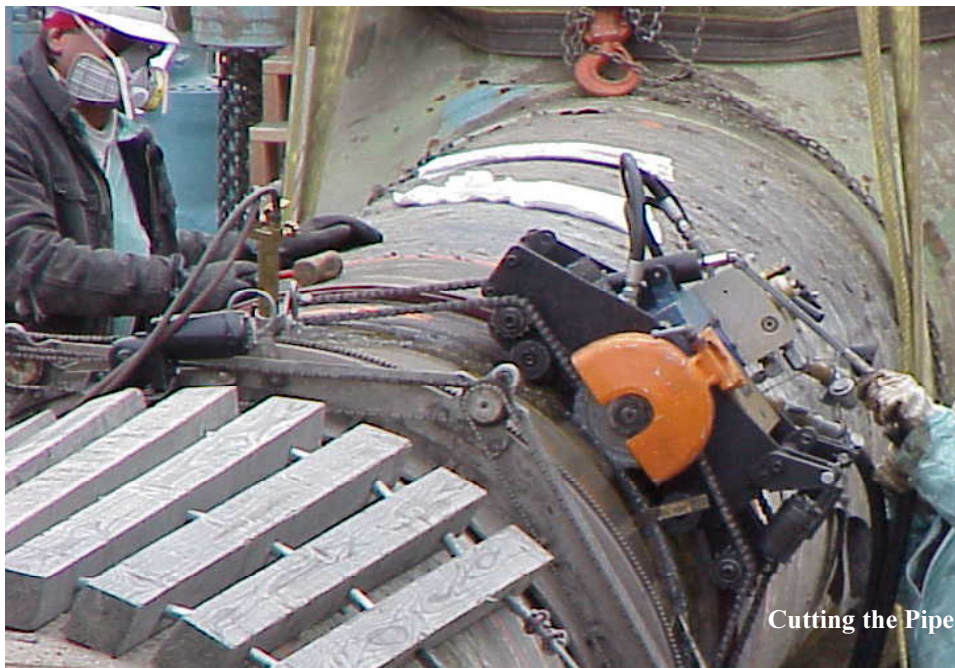
Cutting the Pipe

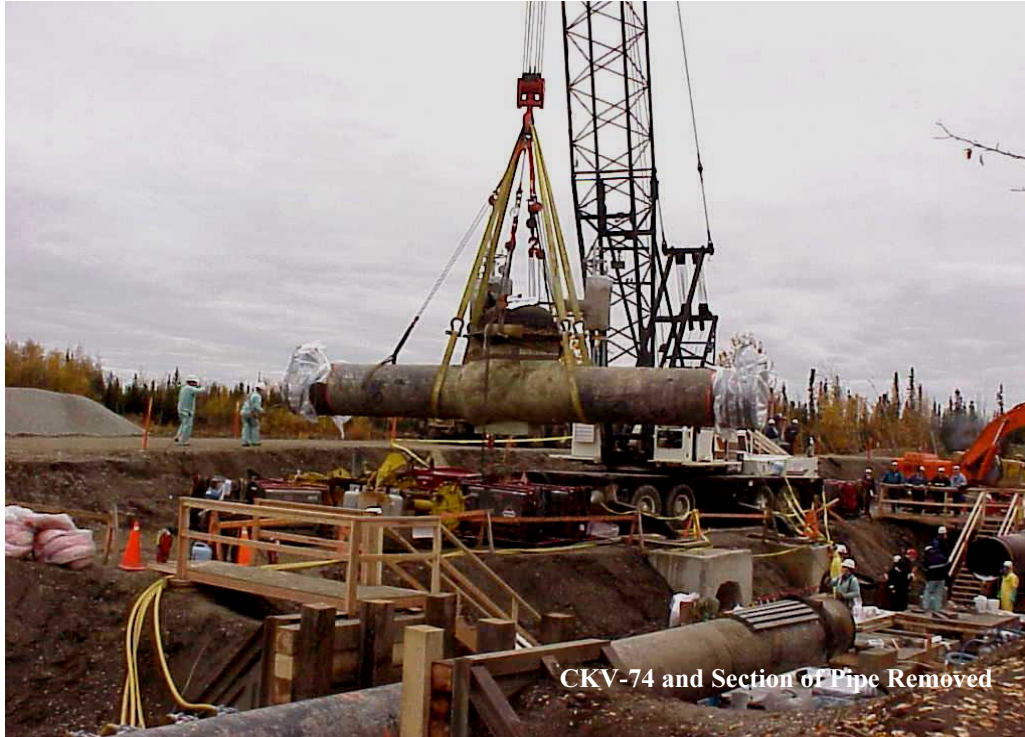
CKV-74 and Section of Pipe Removed

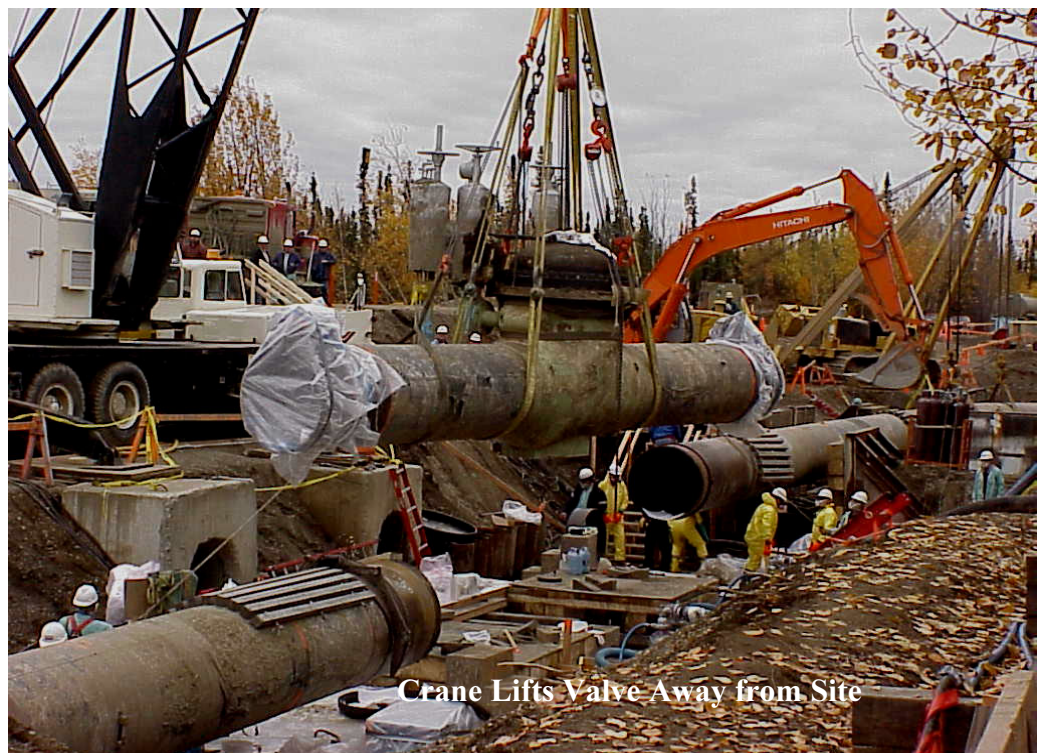
Crane Lifts Valve Away from Site

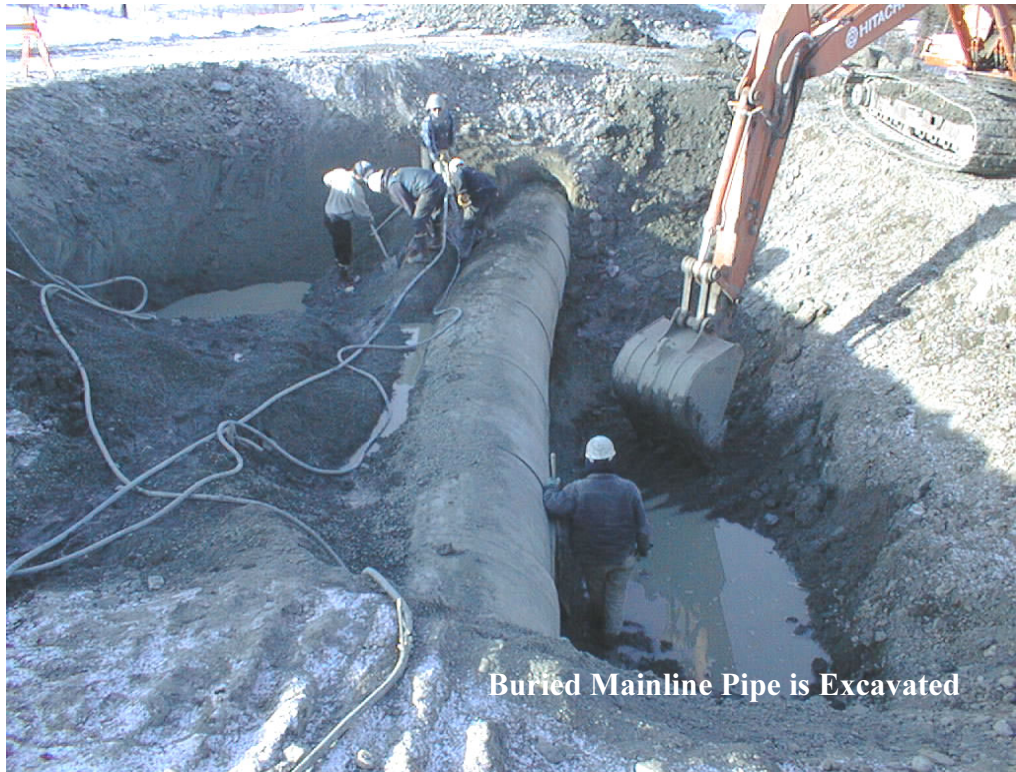
Buried Mainline Pipe is Excavated

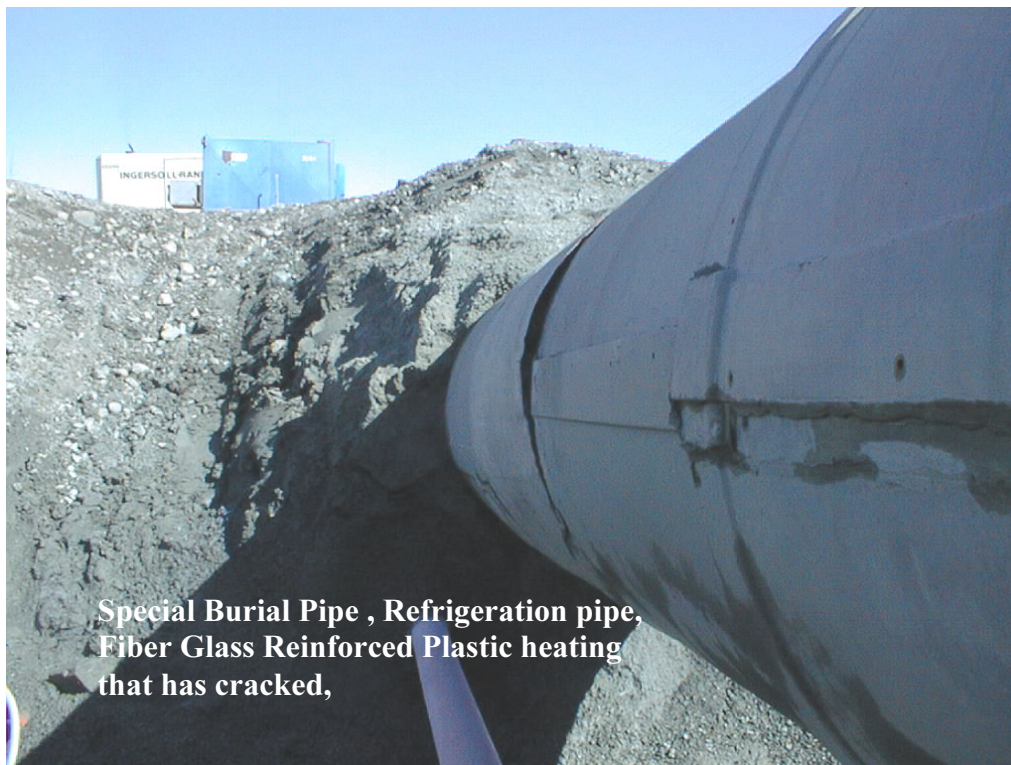
**Special Burial Pipe , Refrigeration pipe,
Fiber Glass Reinforced Plastic heating
that has cracked,**

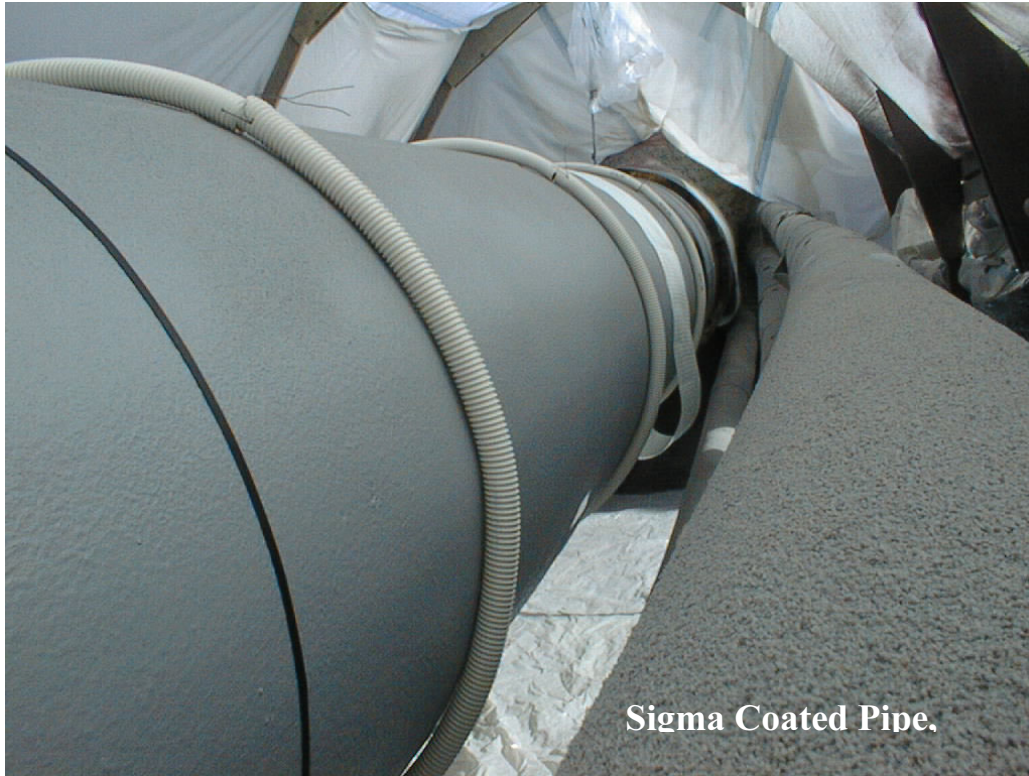
Sigma Coated Pipe.

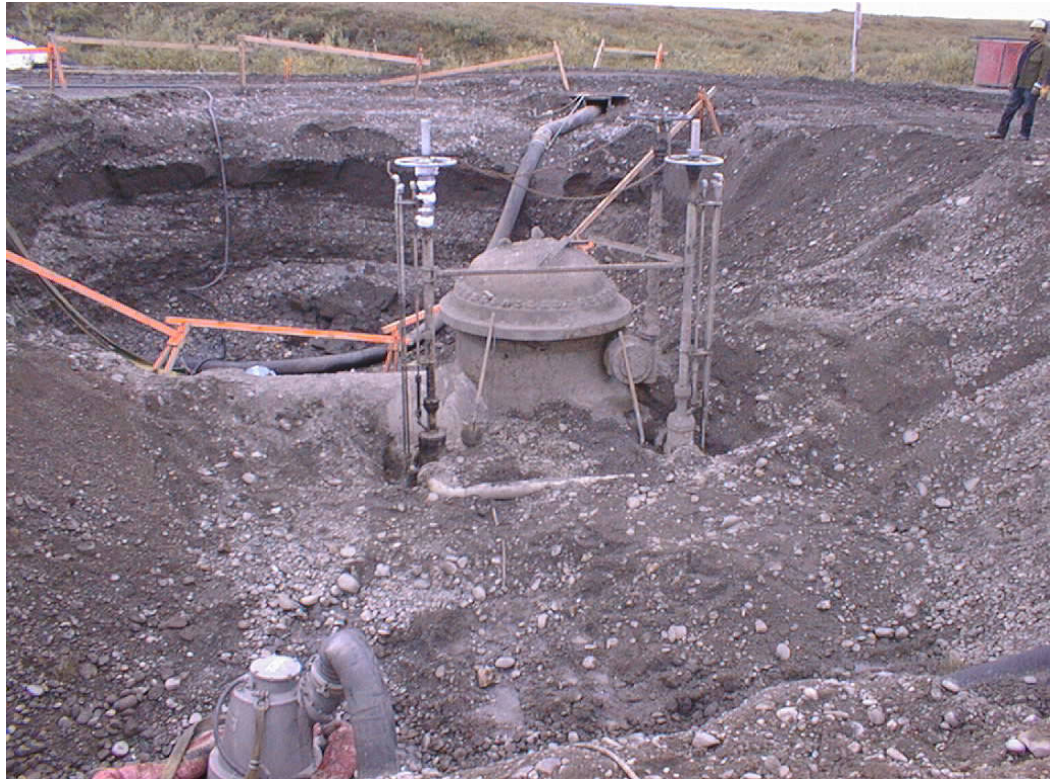
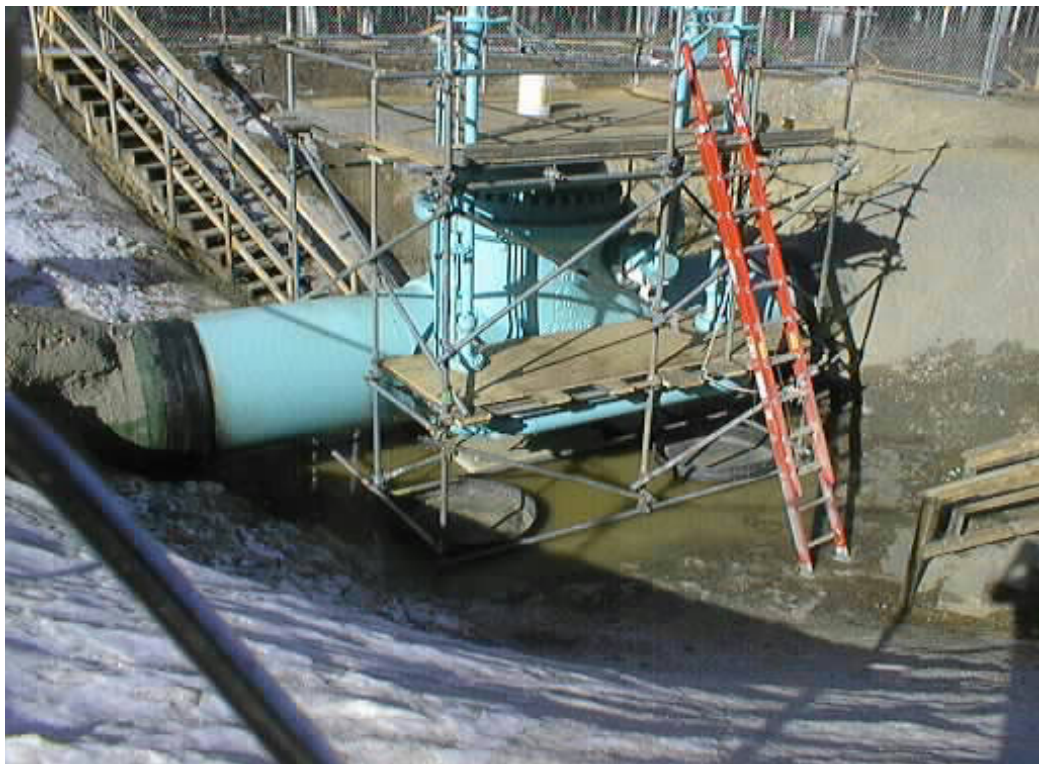
Buried Check Valve Investigations
